SFB 1086SX Acoustic:

Sound values for fixed window 1086 SX, 1230x1480

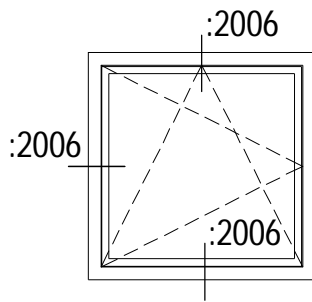
Glass	Rw	Rw+C	Rw+Ctr	Report
T4-16-4-16-4) <sup>1</sup>	32dB	30dB	26dB	4P02108-1
T6-16-4-16-8,8) <sup>1</sup>	42dB	40dB	36dB	4P02108-2
TS50/51) <sup>2</sup>	46dB	44dB	39dB	4P02108-3

Sound values for inward opening window 1086 SX, 1230x1480

Glass	Rw	Rw+C	Rw+Ctr	Report
T4-16-4-16-4) <sup>1</sup>	33dB	32dB	28dB	4P02108-4
T6-16-4-16-8,8) <sup>1</sup>	41dB	39dB	34dB	4P02108-5
TS50/51) <sup>2</sup>	45dB	44dB	40dB	4P02108-8
